**Land at Glebe Farm, St
Endellion
St. Endellion
Cornwall**

**Initial Heritage Assessment
on behalf of:
St Endellion Parish Council
April 2023**

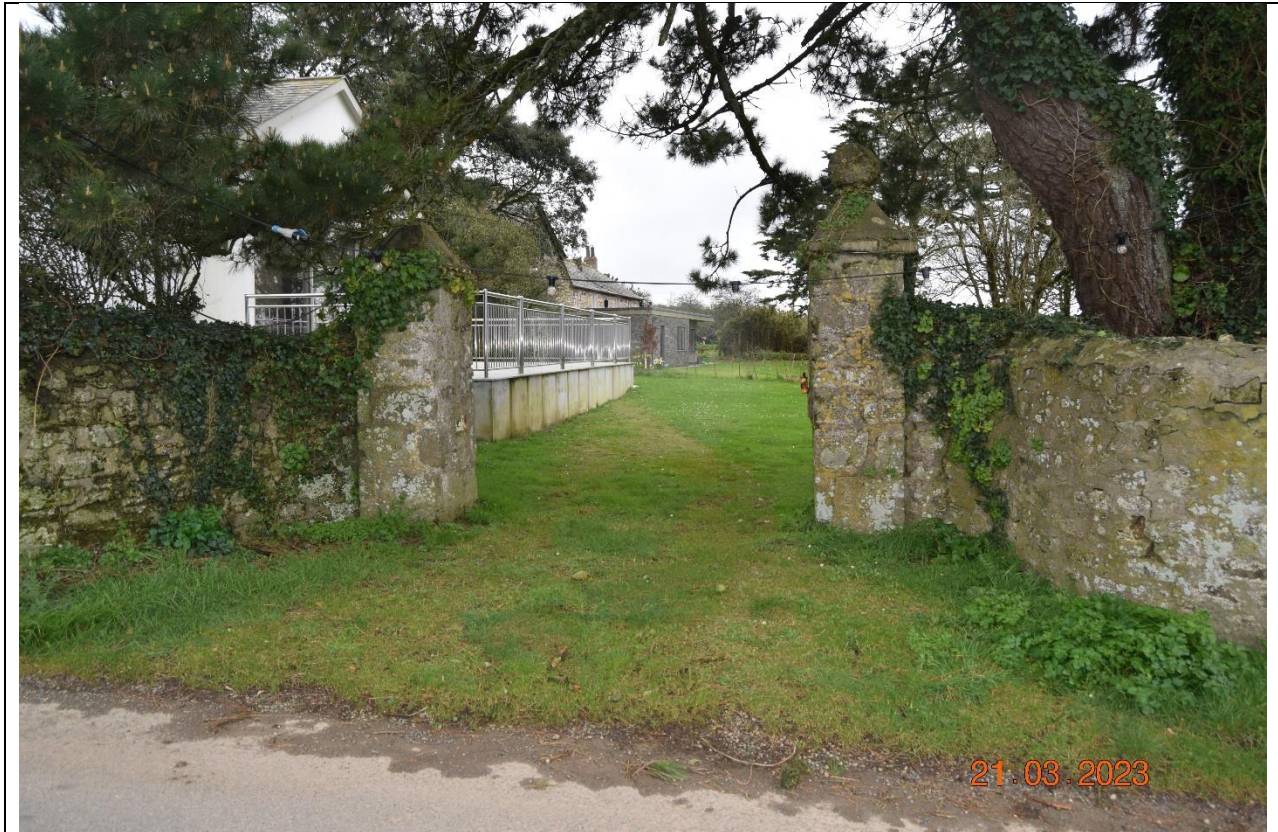
In November 2017 planning and listed building consent was granted for an extension and alterations to the building. The now completed works saw the removal of the various 1960s rear extensions and their replacement with a new single storey extension which has a larger footprint, sympathetic repairs to the main house and revisions to the grounds which reduced the garden curtilage and created a new vehicle access. The gateposts of the original access way still remain but the driveway has been grassed over and the part of the former garden is now used by the Parish Hall.

Former entrance to the Rectory. Raised deck of parish hall extension extends over route of original driveway

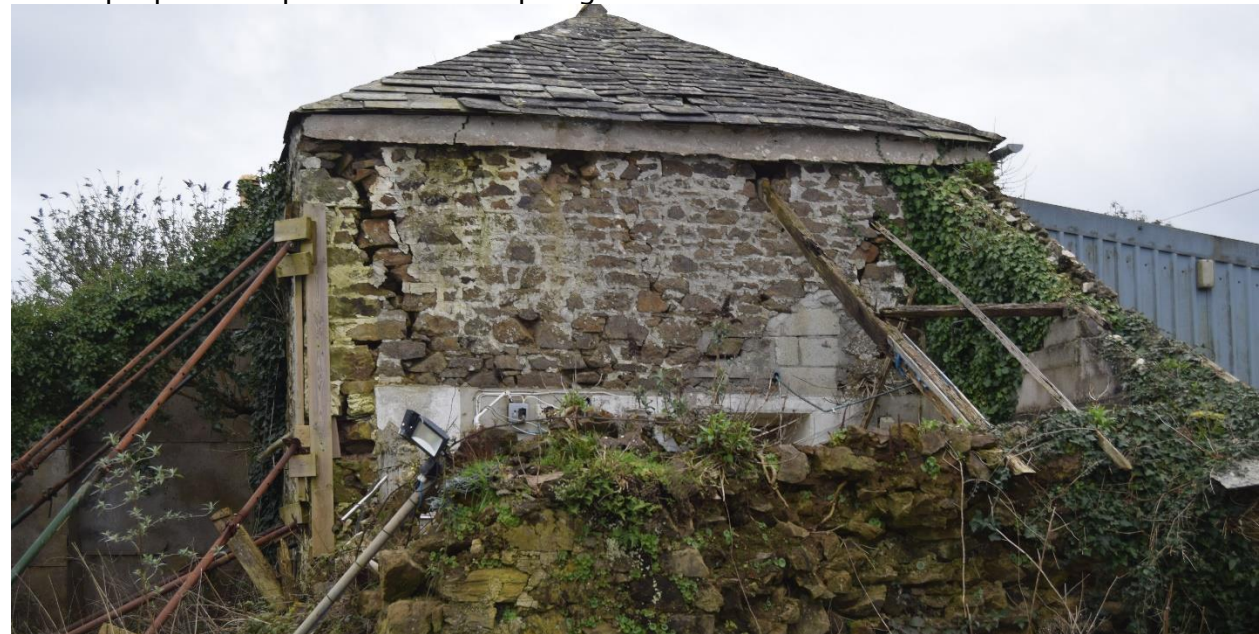
The exterior of the house as described above is unchanged. However, the former two- storey stone straw barn that is attached to the north end of the house and accessed separately off the land to Port Quin is currently derelict and relying on metal props to stop the walls collapsing.

Trehaverock House itself maintains its integrity. However, the Straw Barn attached to the northern end of Trehaverock House needs repair, only propping is preventing its collapse.

Development could have a very positive impact on the setting and legibility of the listed structure. The removal of the modern metal barn on the eastern elevation of the Straw Barn would be a positive. This could then enable the repair and re-use of the former Straw Barn and return the row of buildings to their original form and appearance. The redevelopment also offers scope to create a formal entrance and

route through the Straw Barn into the former farmyard at the rear of Glebe Farm.

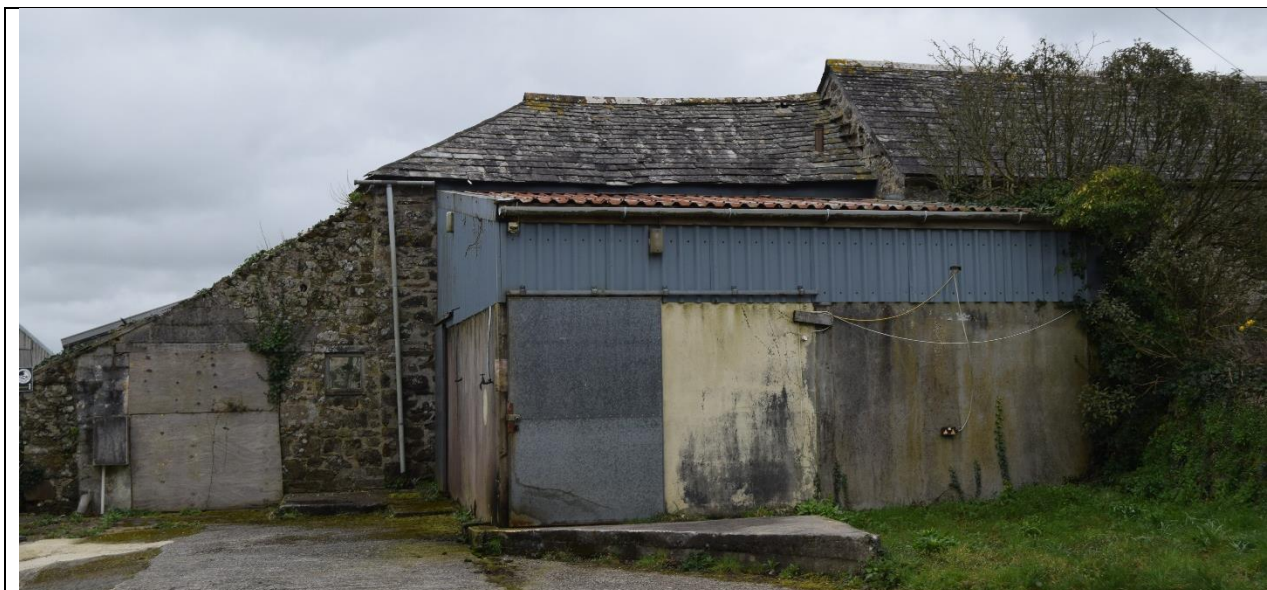
The single storey stone barn that partially wrapped around the straw barn is also in a state of disrepair and has had its roof removed. The later rendered block and metal roofed lean-to barn that was added to the eastern (front) elevation of the two-storey straw barn completely obscures the original front elevation.

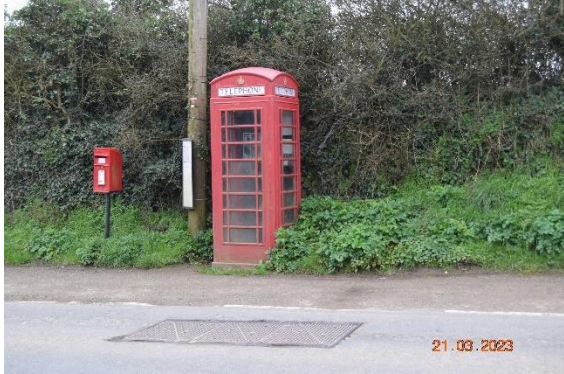
Asset Name: K6 Telephone Kiosk	
Location: Opposite church of St. Endelienta on B3314 at grid reference SW99719 78625	
Designation: Grade II	Type of Asset: Telephone Kiosk
Heritage Asset Grading: Medium	Listing Number: 1332611
Distance from Development: 50m	Date Listed: 3 July 1990
Description summary: Telephone kiosk, Type K6. Designed 1935 by Sir Giles Gilbert Scott. Made by various contractors. Cast iron. Square kiosk with domed roof. Unperforated crowns to top panels and margin glazing to windows and doors.	
Current condition: The kiosk is intact and still operational.

Authenticity: Maintains its authenticity being one of the few red telephone kiosks still functioning as a phone box.	
Integrity: The telephone equipment within the kiosk has been updated however the structure itself maintains its integrity.	
Inter-relationships: The kiosk sits alongside the settlement's post box and west bound bus stop providing three vital rural services.

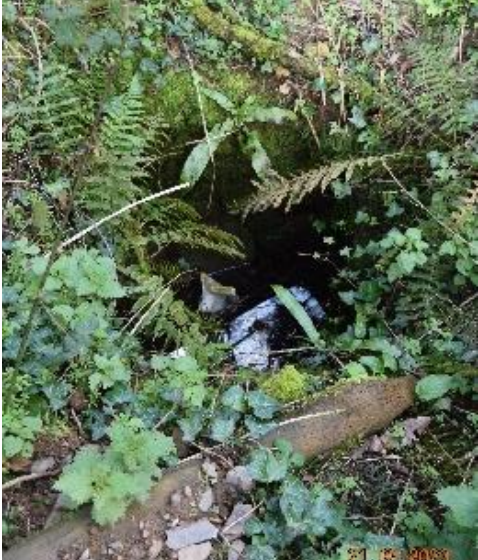
Asset Name: Early Medieval/Medieval Well	
Location: 30m to West of Pennant Cottage	
Designation: Undesignated	Type of Asset: Holy Well 410-1539 AD
Heritage Asset Grading:	HER Number: 17940
Distance from Development:	Date Listed: 26 Jun 1987
Description summary: Lane-Davies says that two wells are recorded in William of Worcester's list of the children of Brychan (Endelient), one being "more distant from the church, more frequented by St Endellion". Quiller-Couch says there are no legends associated with the well, which in 1894 was frequented by drawers of water. The spring is said to be never failing.	
Current condition: The well remains in water though it is understood that nearby abstraction, since ceased, did cause it to dry for a period.	
Authenticity: The well appears to be intact and undamaged.

Integrity: The well maintains its integrity and is in water.	
Inter-relationships: None	
Visual connectivity/setting: The well is uncovered with no protection around it. It is however hidden from casual view and users of the public footpath by an earth bank.

Potential for impact from development: Any water abstraction on the proposed development site could adversely impact on the site. As a functioning watercourse it may have the potential to receive surface water and/or treated wastewater from the proposed development.
